REXMONT NO. 2 DAM

NDI NO. PA-00594

LEBANON COUNTY, PENNSYLVANIA

**PHASE I INSPECTION REPORT
NATIONAL DAM INSPECTION PROGRAM**

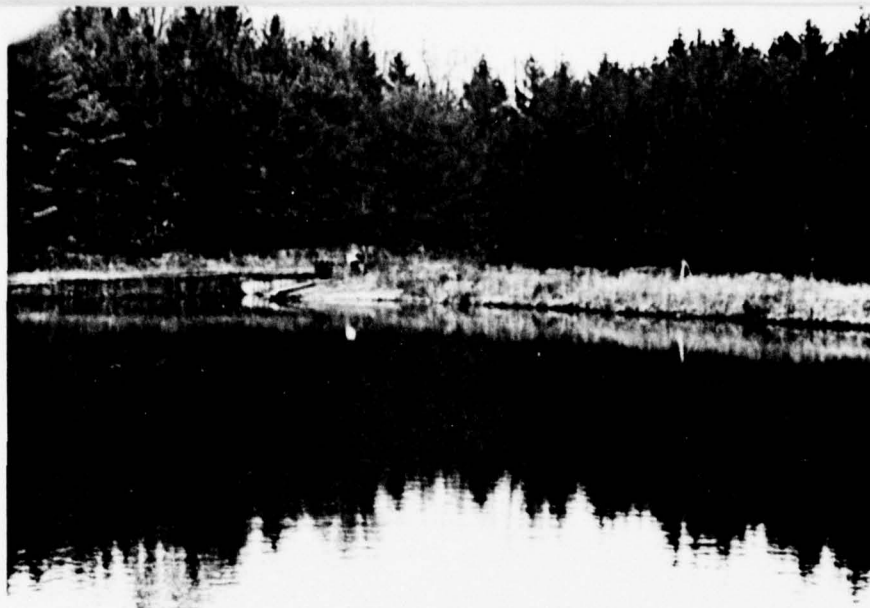
The upstream slope is brick paved and appears to be in excellent condition. Above the normal pool level, grass and some weed growth is covering the brick. The top of the dam has high grass and a footpath. The edges are somewhat rounded off and a slight variation in width was noticeable, but this was not considered serious. The horizontal alignment of the dam was good, with a sharp turn near the left end of the embankment. A survey of the dam profile indicates a fairly level embankment with only one point below the design elevation of 680.0 (see Appendix A).

Upstream Slope
and Forebay

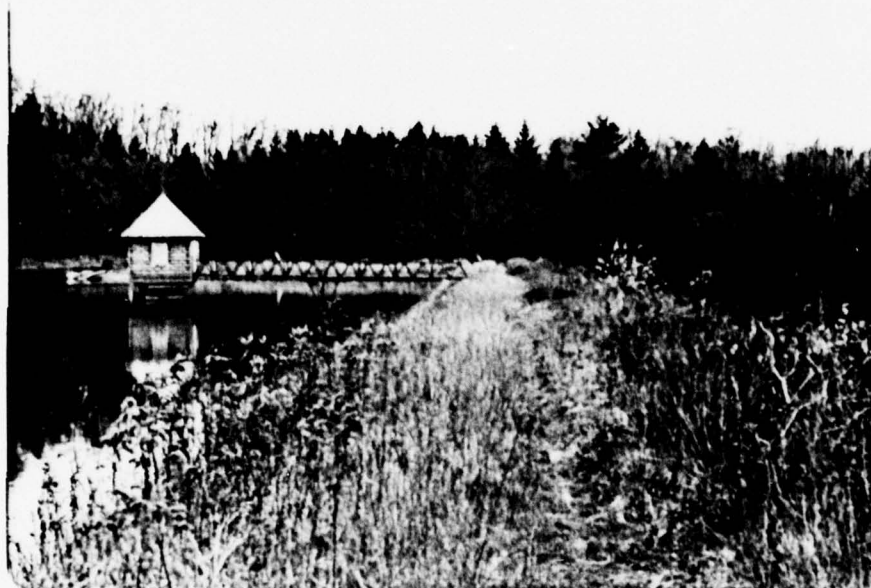
Top of Dam

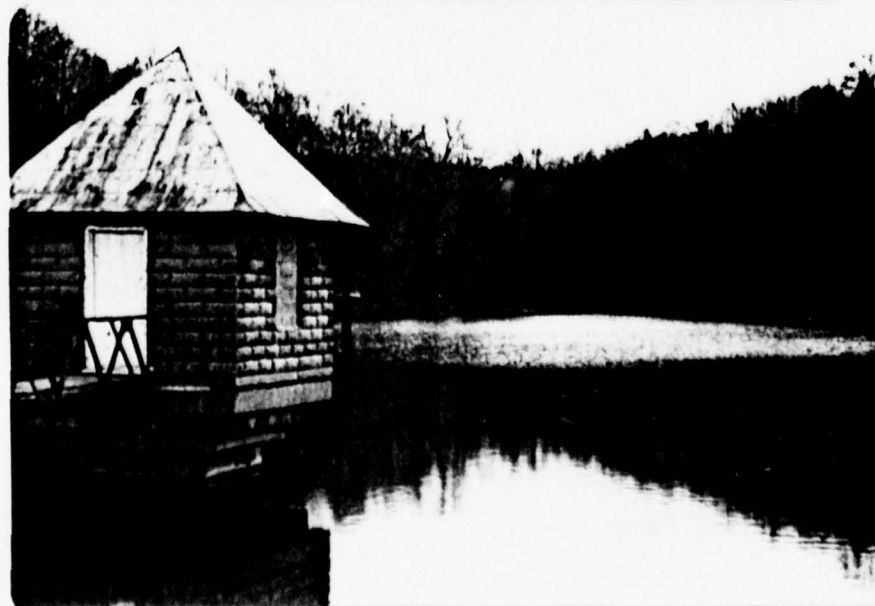
The intake structure is located on the upstream side of the embankment and consists of a concrete tower with a stone building enclosing the operators platform. Access from the breast of the dam is by a steel truss footbridge. The structure and bridge were in good condition. There are three gate operator stands inside of the building. The lower sluice gate, installed for drawdown purposes, was partially opened during the inspection. Drawings indicate that a 16-inch and a 20-inch pipe lead to the downstream Rexmont No.1 reservoir or directly to the City of Lebanon. The reservoir was drawn down in 1970, but the owner's representative did not recall how this was accomplished. The valve pit is located on the downstream slope. This structure was raised when the downstream slope was flattened; however, no ladder is available to descend inside and no inspection was made. Drawings indicate that

Reservoir and
Control Tower

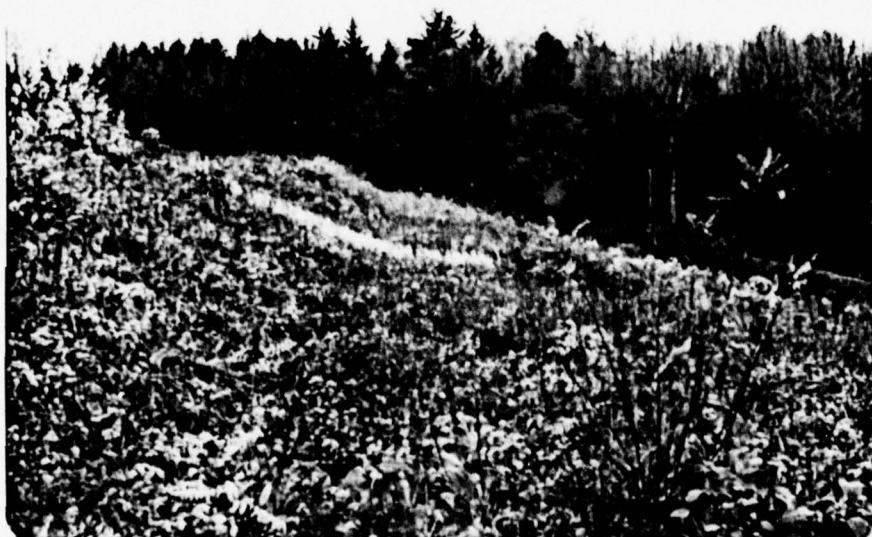
Downstream Berm

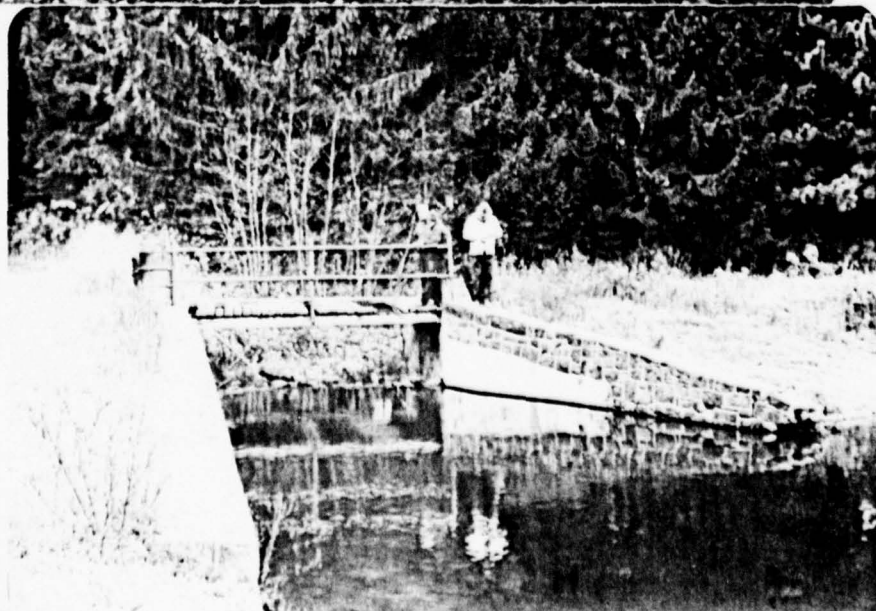
The spillway is located in the left abutment. The approach to the spillway weir is shallow and has stone training walls. The weir crest is in good condition with only minor deterioration. The abutments consist of cemented stone walls. The discharge channel of the spillway makes an abrupt 90° turn about thirty feet beyond the weir. The channel narrows down to a rock protected ditch, paralleling the toe of the dam over a length of about 200 feet, at which point the embankment turns away from the ditch. A footbridge provides access over the spillway to the dam breast. The planking on this bridge is in very poor condition. No records of maximum flow over the spillway were available or recollected.

There were no visual indications of unstable conditions of the appurtenant facilities for this dam. The intake tower is in good condition and the spillway and abutment walls will be able to withstand high discharges. The spillway bridge is in poor condition, but this will not affect the safety of the facilities. The spillway chute is overgrown and is located close to the toe of the embankment. A thorough inspection of the stone walls should be made after all brush has been removed.

Spillway Entrance
& Bridge

2. That the footbridge across the spillway be repaired to provide a safe walking path for emergency access.
3. That all brush cuttings on the downstream slope should be removed.
4. That the downstream slope footpath be reseeded to prevent erosion.
5. That the debris in the spillway be removed.
6. That the walls of the spillway chute be closely inspected after the removal of the brush overgrowth.

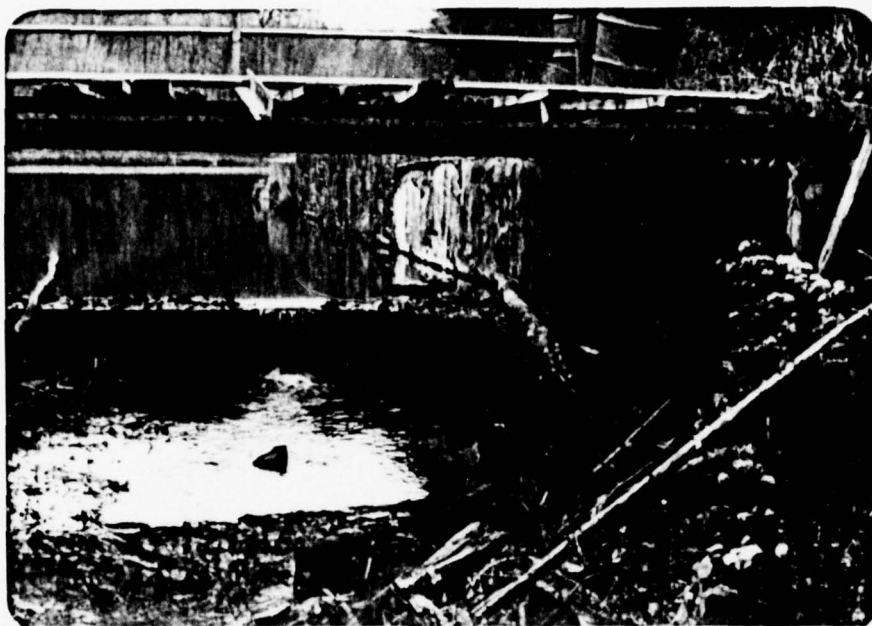
Spillway Looking Upstream Under Bridge

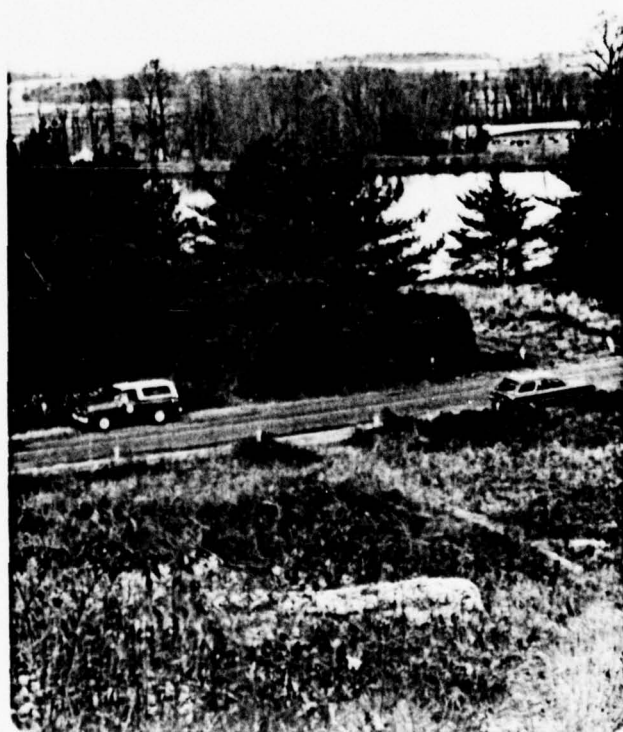
Under normal conditions, the spillway discharges through a small ditch and pipe underneath a road into the next reservoir (Rexmont No.1). If the dam of Rexmont No.2 would fail due to overtopping, the released water would cross the road, destroy the downstream dam and hit several farms and houses located within 4,000 feet of the dam. The hazard category of the dam is considered to be "High", due to the additional loss of life to be expected.

Looking From Dam To Downstream Reservoir

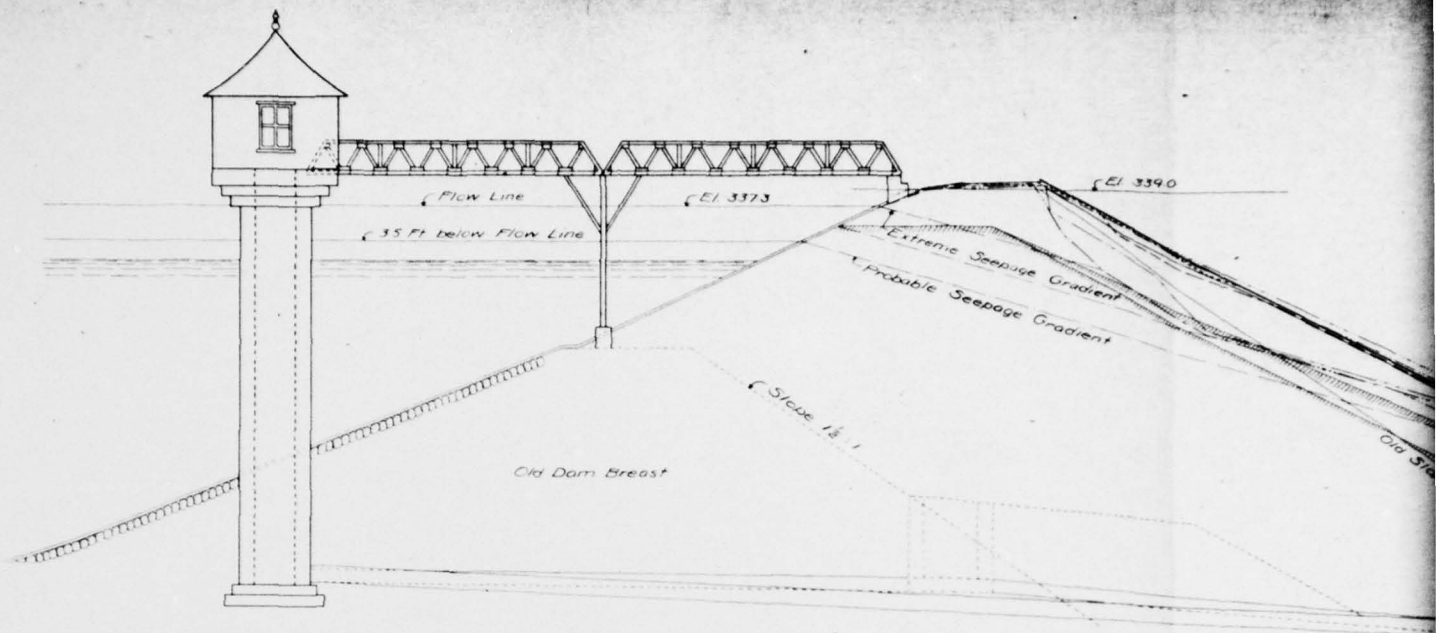
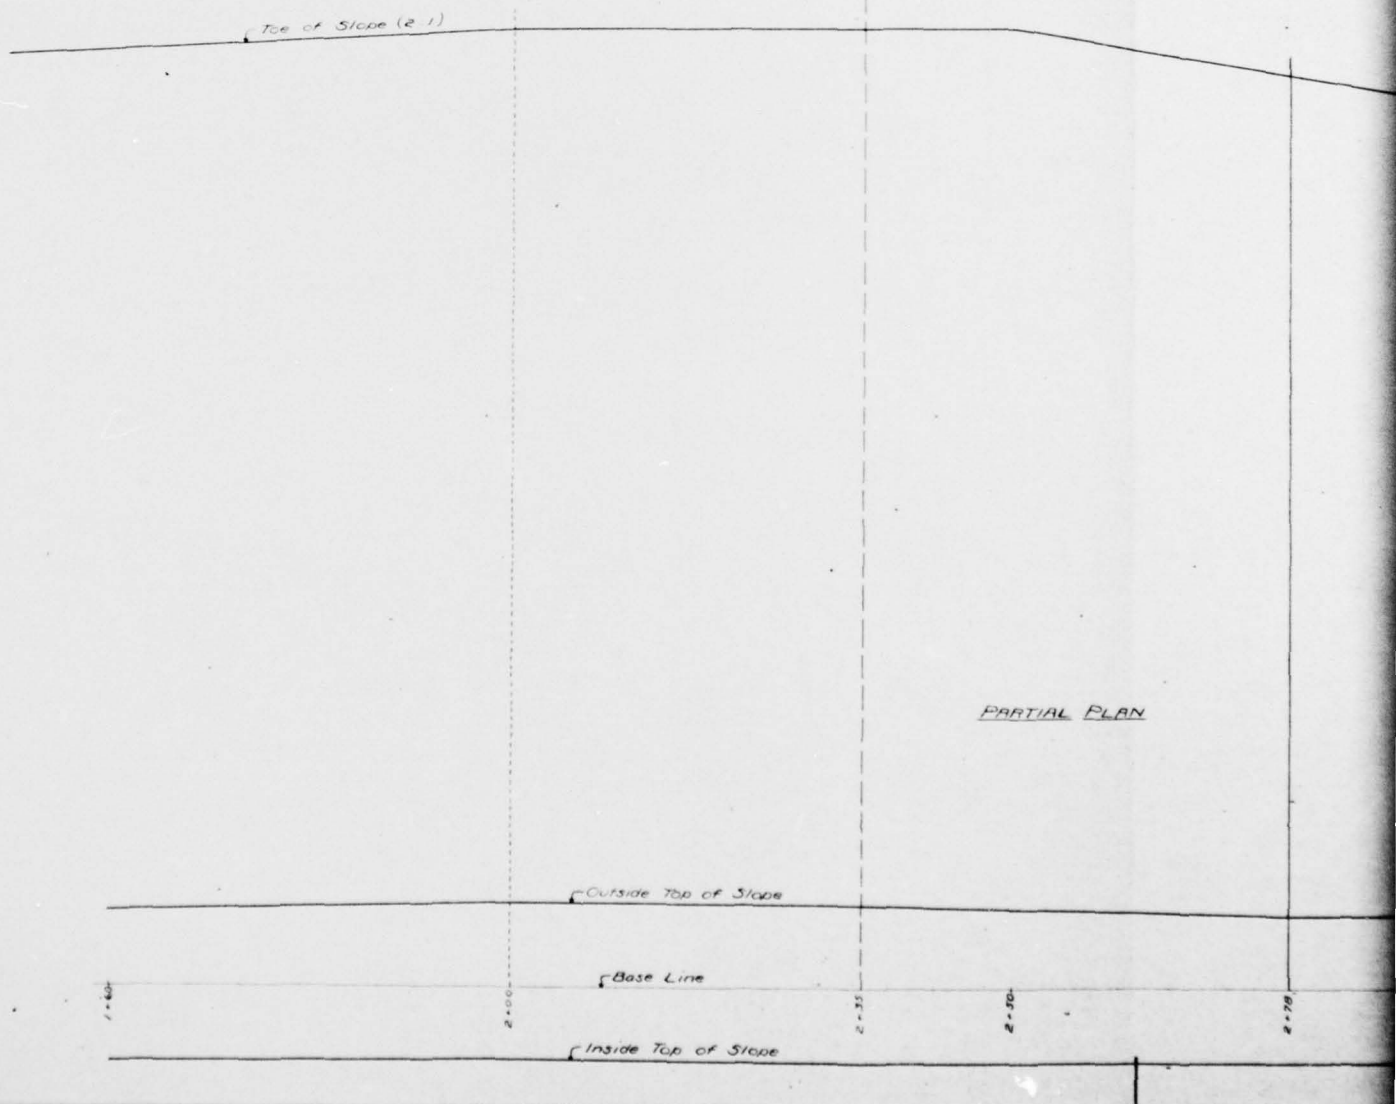
On April 4, 1912, a crack appeared at the downstream edge of the top of the embankment and the embankment settled some and bulged below this settlement about 70 feet west of the gate house. A large slide occurred on April 8, 1912 (Plate VI and VIII, Appendix F). This slide was about 120 feet from the east end of the dam and was about 65 feet long. The riprap and concrete cover and vitrified brick on the upstream slope was supposed to form a membrane against seepage. Numerous cracks and imperfections in this membrane allows water to freely enter the embankment.

CITY OF LEBANON, PA
 SECTION THROUGH DAM NO. 2 AND PARTIAL PLAN
 SHOWING
 SLIP OF APRIL 8, 1912 ON OUTER SLOPE, ETC.
 APRIL 16, 1912 SCALE $\frac{1}{8}'' = 1'-0''$
 Approved [Signature] City Engineer
 S.H. Smith, Del.

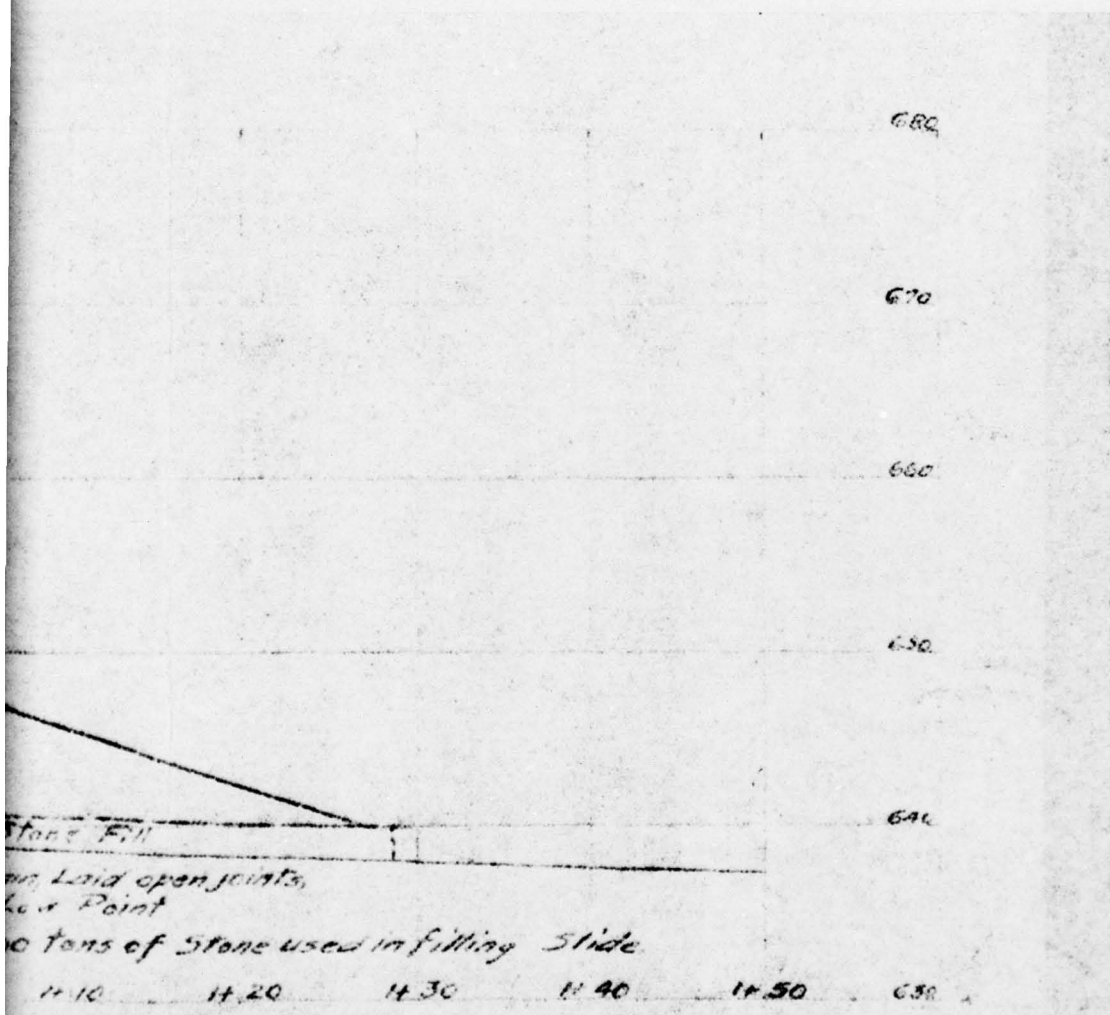
The slide area was backfilled with stone and the spillway crest was lowered 2.5 feet. Although it was recommended to flatten the downstream slope, no changes were made. On July 25, 1925, a serious slide occurred over a length of 110 feet (Plate VIII, Appendix F) at the top of the dam. The width of the slide narrows down to about 70 feet at the toe of the dam. The material flowed beyond the toe over a length of 150 feet, pushing over a wire fence along the highway. Maximum depth of the slide was about 10 feet with a nearly vertical upstream edge and showing distinctly the horizontal layers in the embankment. Considerable seepage appeared to be coming from the embankment with the water in the reservoir at normal pool level. The material of the slide was soft and saturated and could not bear the weight of a person on July 27, 1925. The estimated maximum reservoir level was 2 feet above spillway crest. The slide area was backfilled in the summer of 1925 with stone.

*Section of Slide of Dam #2
of City Supply Dams.*
